ALEXANDER LIBRARY ENTRANCE PLAZA STUDY

RUTGERS UNIVERSITY
NEW BRUNSWICK, NEW JERSEY

JONATHAN HAWKINS
FALL 2011

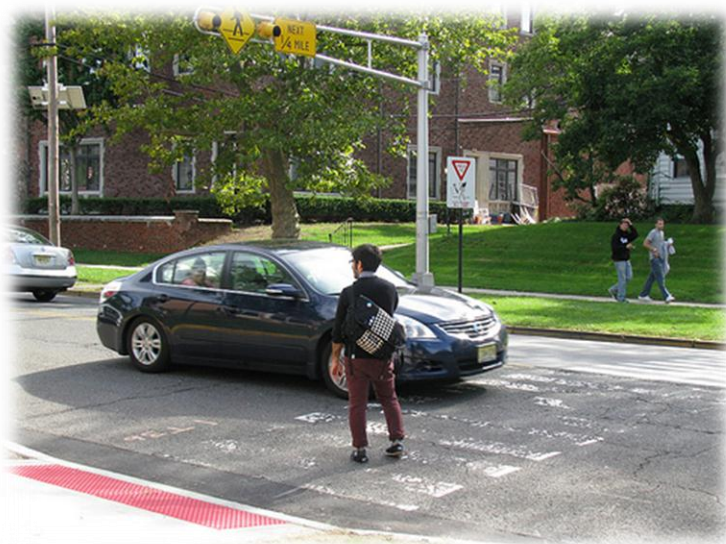
Figure 4: Pedestrian Traffic Entering Alexander Library Entrance Plaza

pedestrians entering the plaza during different times and days (Figure 4). The first observation, between 3:40 and 4:10 PM on Friday, September 16, saw 71 people enter the plaza, with 68 heading toward the library and 3 toward the Communication School. Lunch time Monday, between 11:40 and 12:10 showed an increase, with 91 entering the library and 12 the Communication School. The evening of Tuesday, September 20 was by far the busiest observation period, with 163 pedestrians

entering the library and 10 the Communication School between 8:50 and 9:20 PM. The final observation between 4:30 and 5:00 PM on Wednesday, September 21 showed 106 to the library and a surprising 39 to the Communication School.

The most foot traffic into the library occurred in our 8:50 to 9:20 PM study (Figure 4). Once classes and daily activities end, many students appear to head for the library to study and work on the following day's assignments. Darkness brings with it more safety concerns, and indeed over the last year at Rutgers there have been instances of late night crimes in the College Avenue area. We observed two possible safety concerns during our night visit. One, the plaza area, especially the new courtyard, are not well lit (Figure 13). In fact, the courtyard's sole source of light appeared to be the fluorescent lights inside the library emitting through the windows to the outside. Two, we could not locate an emergency call box. These boxes, denoted by a bright blue light on top, are located throughout the Rutgers campuses to provide a quick connection to campus police in the event of a safety concern.

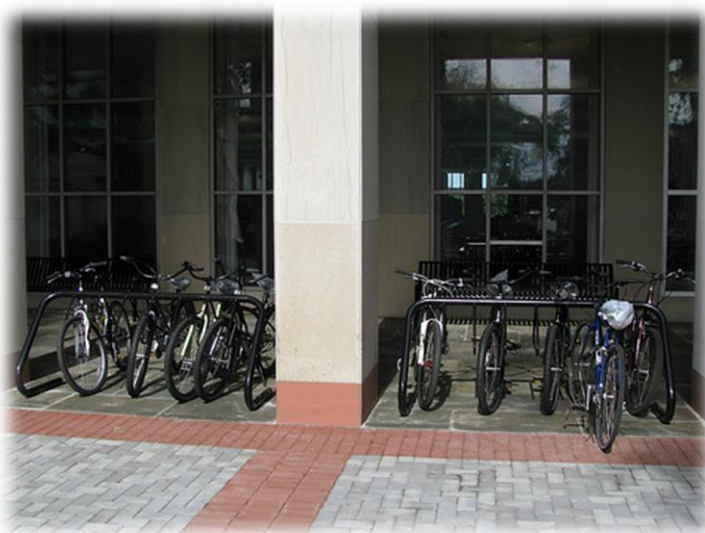
Figure 6: Bike Rack Usage in Alexander Library Entrance Plaza Courtyard

There are three bicycle racks in front of the library with each holding eight bikes. The racks were not at capacity during any of our visits (Figure 6), but during each observation there was at least one bike parked somewhere other than the bike racks. Additionally, new bikes for the new Rutgers bike rental program had arrived before our first observation, as Alexander Library is a pick up location for the program. As the rental program had not yet started during any of our observations, we counted five rental bikes on the racks at each observation. There were 9 other bikes on the racks and 1 chained to a hand railing during the Friday afternoon observation, 5 on the rack and 3 chained in other areas during the Monday morning visit, 7 on the rack and 1 elsewhere in the Tuesday night period, and 11 on the racks and 1 other during the Wednesday late afternoon observation.

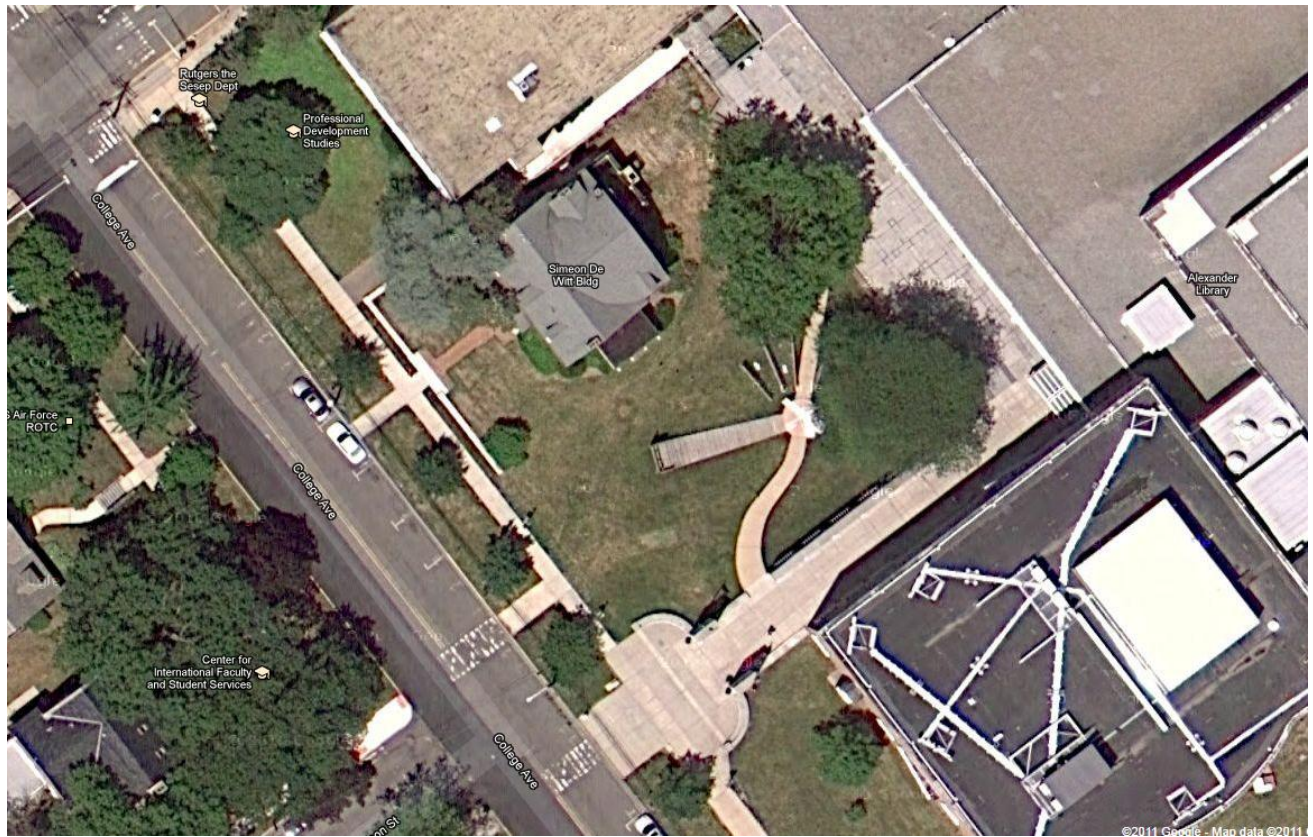
Figure 1: Satellite View of Alexander Library Entrance Plaza

The grassy area in front of the courtyard was never observed as being used for anything other than a through route for pedestrians to and from the Communication School using the meandering sidewalk connecting it to the library's entrance pathway (see Figures 1, 2 and 3). In the grass there are some art installations that seemed to go completely ignored, and a wooden stage that is an eyesore and seems out of place in its location (Figure 9). The School of Communication's Flickr account revealed a photo of the stage being used during Rutgers Day, but at no point during our observations was the stage utilized. The weather was ideal for outdoor activities, so this lack of use of the space over the course of the four days we observed is unlikely to be an anomaly.

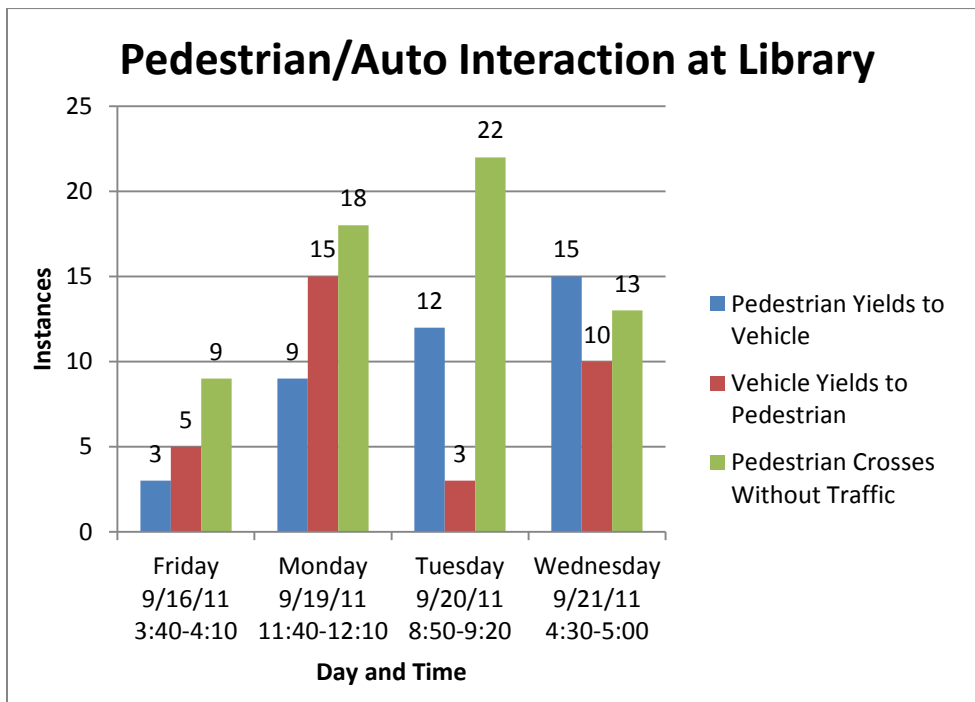
Figure 5: Conflicts between Pedestrians and Vehicles in Front of Alexander Library Plaza

The next data collection involved the pedestrian/vehicle interactions in front of the library (Figure 5). There was a correlation between the number of pedestrians entering the plaza and the total number of pedestrians using the crosswalks, but no correlation with the way pedestrians interacted with automobiles. If a pedestrian stopped at the entrance to the crosswalk or in the crosswalk to wait for a vehicle to pass, the interaction was counted as pedestrian yielding for vehicle. If a vehicle stopped or slowed in front of the crosswalk to allow the pedestrian to cross, it was counted as a vehicle yield. During Friday afternoon's 30 minute block, 17 pedestrians were observed using the two crosswalks on College Avenue, with three yielding to vehicles, five crossing after vehicles yielded, and nine crossing without traffic conflicts. Monday's lunchtime observation showed a more than doubling in pedestrians utilizing the crosswalks, with the highest share (18) crossing without conflict, 15 crossing with automobiles yielding, and 9 waiting as vehicles failed to yield. Tuesday's observation at night showed the most concerning results, with 12 pedestrians having difficulty crossing due to vehicles not stopping and only 3 instances of

cars yielding. This may indicate better lighting is needed. Wednesday had the highest amount of pedestrians yielding to vehicles (15), with 10 vehicles yielding to pedestrians and 13 crossing without traffic. This could be due to traffic being heavier and drivers in more of a hurry during rush hour.

6. Repaint crosswalks

7. Traffic calm College Avenue before library

Traffic calming elements for the southbound lane of College Avenue approaching the library should be explored, including moving the pedestrian warning signs to be located before vehicles reach the crosswalks. A “yield to pedestrians” sign should be placed on the center line before the crosswalks.

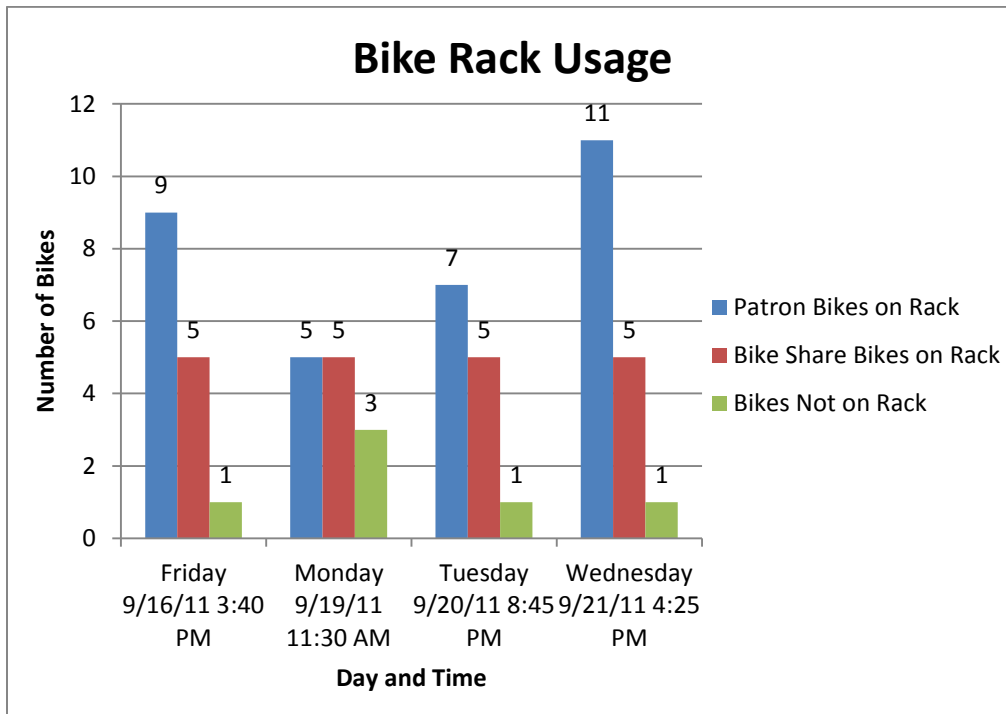
False. Even in beautiful weather, the bicycle parking was never over capacity. There could be some potential confusion with the rental bikes being mixed in with patrons' bikes, but aside from that the space seemed to be functioning as desired.

3. Separate bike rental facilities and patron bike racks

Rental bikes should be located separately from patron bikes in their own rack with appropriate signage and markings.

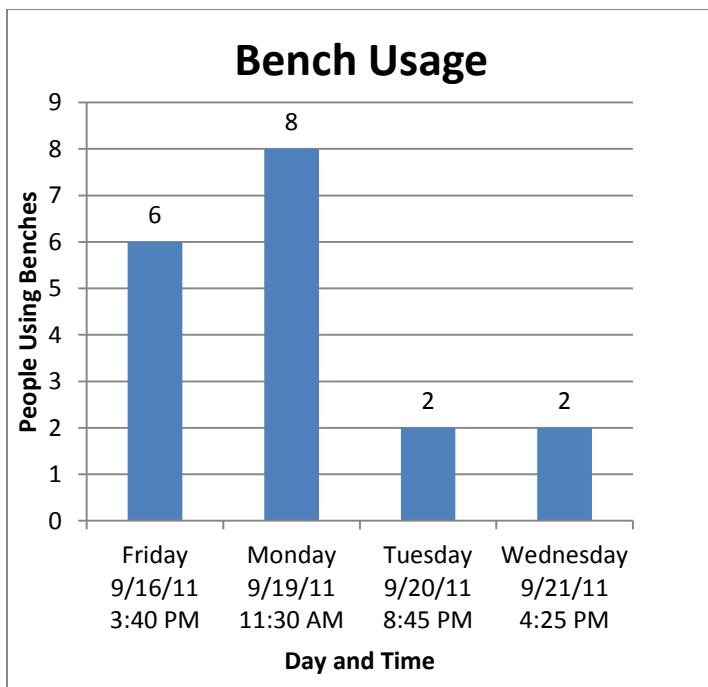
Figure 7: Bench Usage in Alexander Library Entrance Plaza Courtyard

Fourteen new benches were installed in the courtyard, and these were used sparingly during our visits (Figure 7). There were 6 people using the benches at 3:40 PM Friday, 8 at 11:30 AM Monday, 2 at 8:45 PM Tuesday, and 2 at 4:25 PM Wednesday.

The courtyard was not particularly active during any of our observations. Bicycle riders used it to park their bikes in the racks, but did not linger and left to enter the library or Communication School immediately after. The benches served primarily as a place to perform activities that were not allowed or inappropriate inside the library, such as smoking and talking on cell phones. Occasionally someone would be observed socializing with another person or enjoying the nice weather and reading. No one in the courtyard was observed eating or drinking an item purchased from the Scarlet Latte café inside the library.

1. Add tables and chairs to courtyard

A few small tables and chairs would support a greater range of activities for the courtyard and better entice café customers to eat and drink outside.

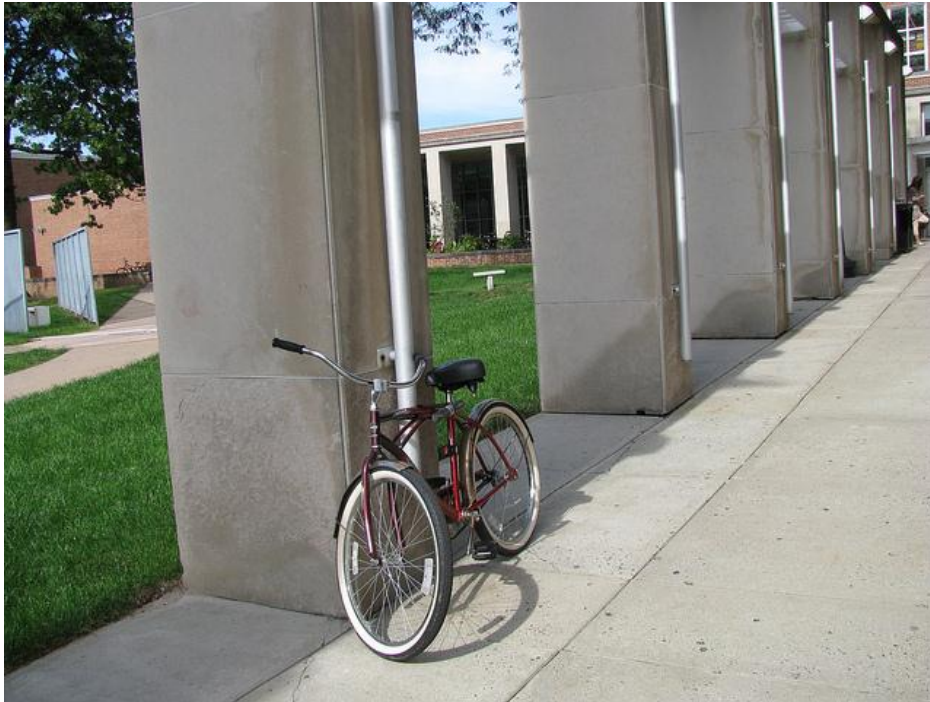
Figure 8: Bicycle Not Parked in Rack

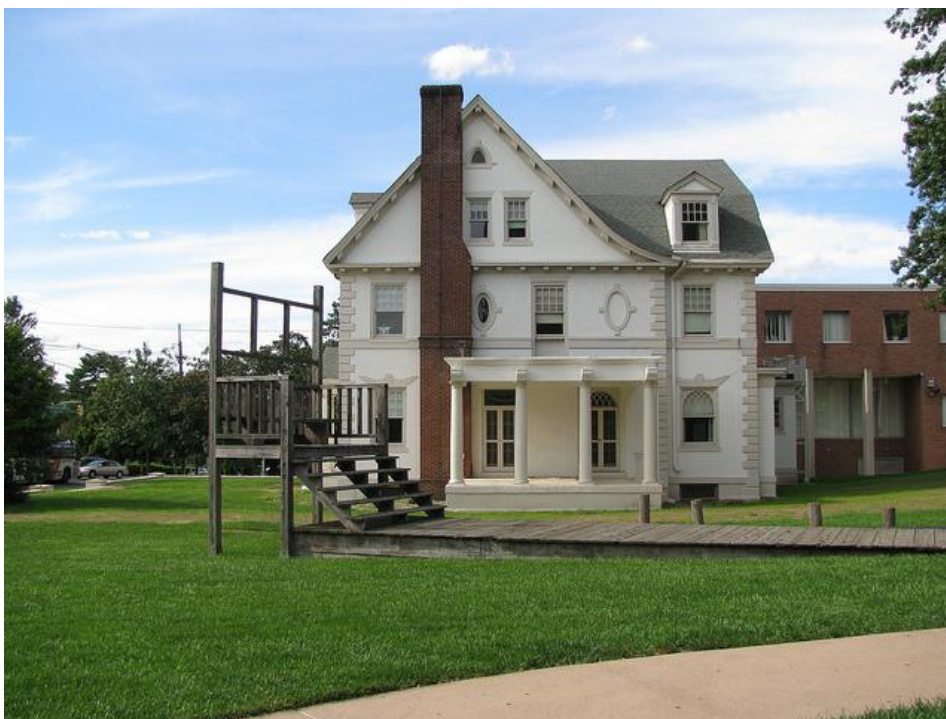
Figure 9: Stage in Front of Alexander Library

Remove the stage and landscape the open space to be more attractive or extend the courtyard to make a larger public plaza.

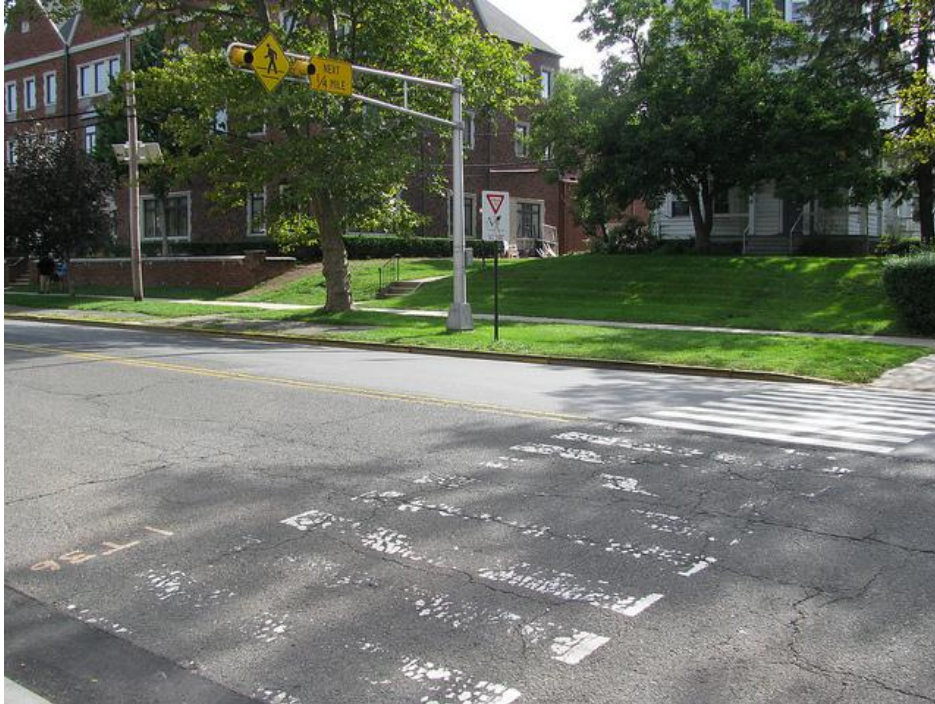
As the quantitative counts revealed, pedestrians often struggled to cross the street to get to and from the library due to automobile drivers not yielding. We observed several factors at play in this scenario. The southbound lane of College Avenue appeared to have been recently repaved, while the northbound lane looks as though it has not been repaved in quite some time. The crosswalks on the southbound lane were repainted after paving, but the portions in the northbound lane were not and are extremely faded. This leads to crosswalks that are likely difficult for drivers to see (Figure 10). Furthermore, signs warning drivers of crossing pedestrians are situated beyond the library crosswalks, and one of them is faded (Figure 11). Drivers may see these signs too late to slow down for the library crosswalks. Finally, with the study area being located near the northernmost end of College Avenue, we observed that drivers turning onto the road from Huntington St, George St, and Route 18 accelerated as they entered the street, potentially arriving at the crosswalks at speeds too fast to allow drivers to recognize the need to yield to pedestrians.

Figure 10: Crosswalk in Front of Alexander Library

Even if the northbound lane of College Avenue is not repaved, the faded crosswalks should be painted.

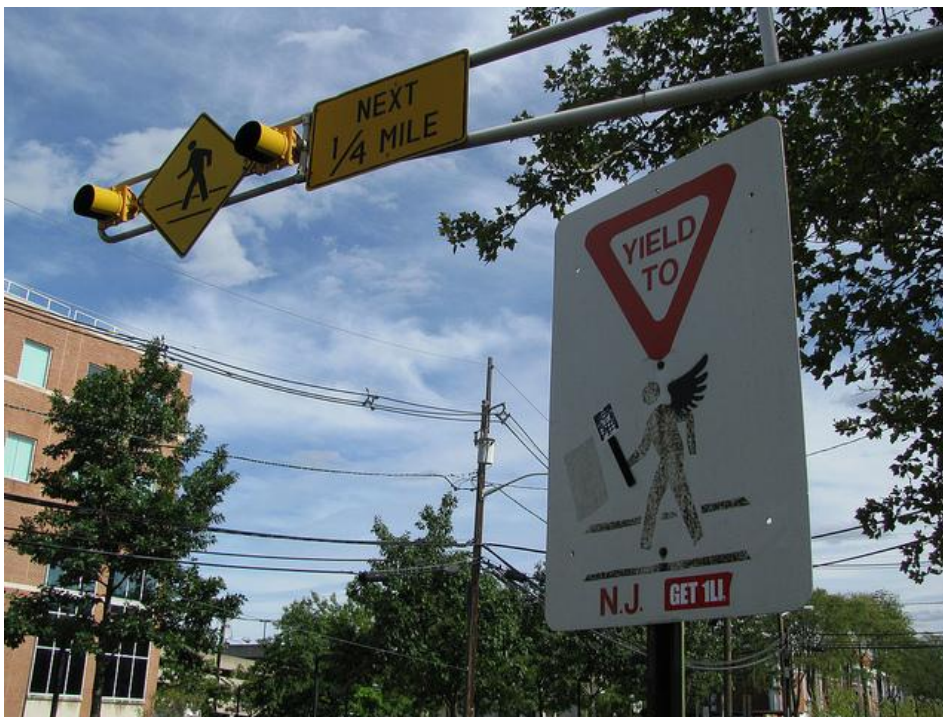
Figure 11: Vehicle Yield Signs Just After Crosswalks in Front of Alexander Library

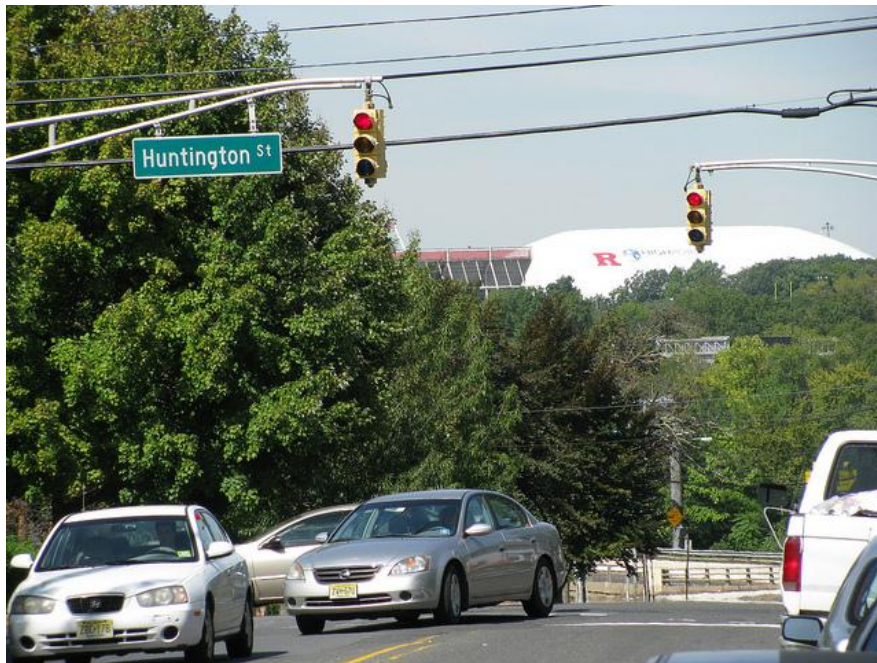
Figure 12: Vehicles Turning Onto College Avenue and Accelerating

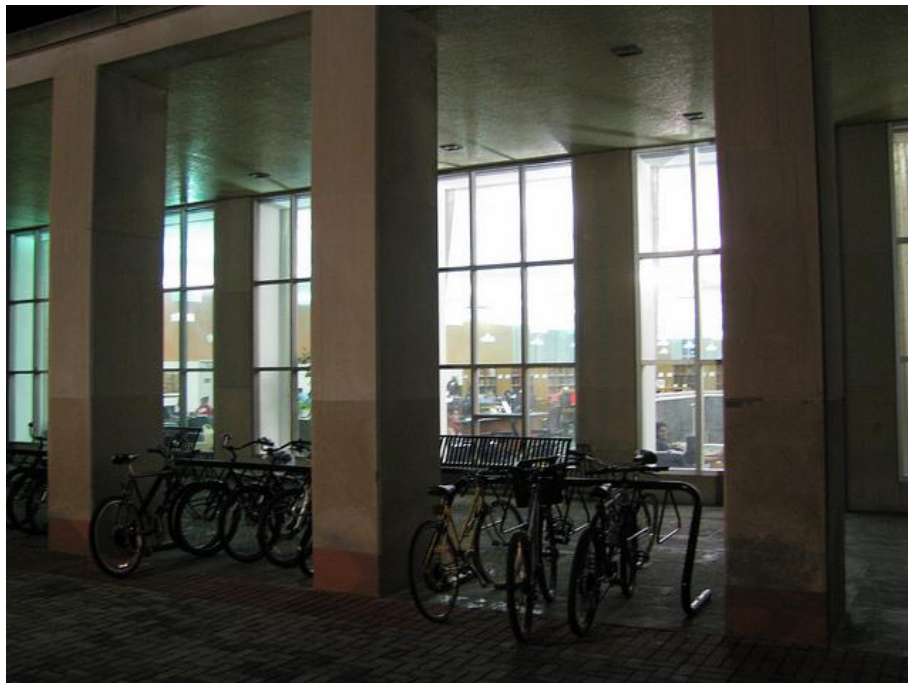
True. The difficulty for pedestrians in getting vehicles to stop, especially at night and during rush hour, was concerning. Additionally, the poor lighting both on the street and in the library courtyard could be improved.

Figure 13: Alexander Library Courtyard at Night

Lighting should be installed in the new courtyard, and lighting on College Avenue in front of the library should be improved.

An emergency call box in a prominent location in front of the library could deter crime or aid crime victims.
